AAV IRAM TRANSMISSION REVIEW

INTERIM REPORT TFLRF No. 334

By
Gary B. Bessee
Douglas M. Yost
William E. Likos
Dr. Richard A. Page
Daniel J. Benac
U.S. Army TARDEC Fuels and Lubricants Research Facility (SwRI)
Southwest Research Institute
San Antonio, TX

March 1998

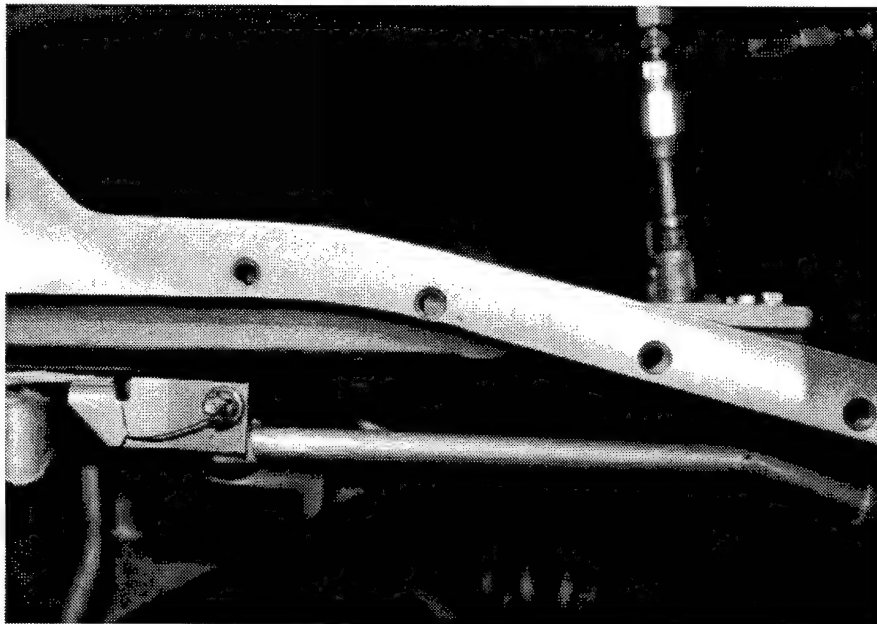
Figure 1. Insufficient Gasket Area

The gasket leakage stems from the insufficient gasket area (Figure 1), housing warpage (Figure 2), and poor quality gasket material. The access plate on the rear of the transmission, a common leakage area, has a cutout that leaves a very thin gasket surface, plus a very sparse bolt pattern in the same area. Attempts to torque the plate bolts to increase the pressure on the gasket tend to buckle the plate corner effectively reducing the pressure on the gasket. Additionally, a matched end plate and speed change housing may have had the bolt pattern shifted during original production such that insufficient gasket sealing surface remains. Gasket leakage also occurs due to warpage of the speed change housings. The warpage stems from the welding procedures used to repair the cracks in the housings (Figure 3).

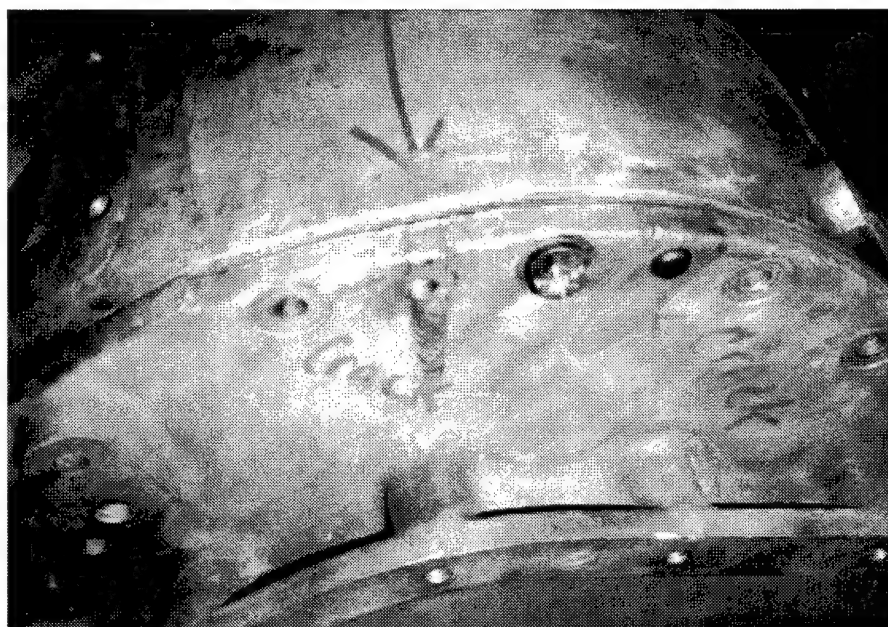
Figure 3. Crack at Dowel Pin Boss

Housing cracks appear due to disassembly and handling procedures and incorrect vehicle operation (Figure 3). Each time a transmission is rebuilt increases the likelihood of speed change housing damage. An example is that a crack typically shows up at a location consistent with the lower jackscrew used to separate the end plate from the speed change housing. It was noticed that there was localized yielding of the aluminum housing material at all jackscrew locations. Cracks were evident at the lower speed change housing dowel pin boss (Figure 3). The cracks in the dowel pin boss are typically repaired with Devcon epoxy putty. Another typical speed change housing crack occurs due to failure of the fan drive universal joint. The fan drive universal joint fails, and the flailing drive shaft impacts the speed change housing causing cracks. An ECP was developed to prevent this damage but was never implemented.

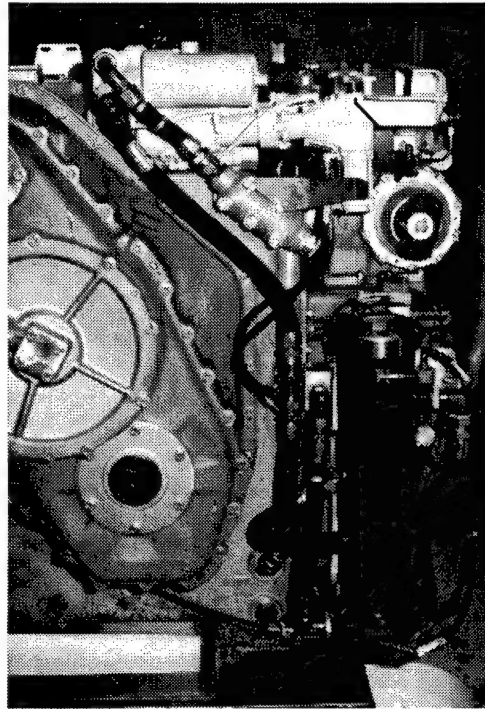
Figure 4. Improved Filtration System

The IRAM transmission has incorporated a new Parker filtration system, which improved the efficiency and load capacity of the older filtration system (Figure 4). The drawing for this system is shown in Figure 5. This filtration system efficiency is rated as being 50% efficient at 2 μm ; 95 % efficient at 8 μm ; and 98.7% efficient at 10 μm . The apparent capacity for the Parker system is 200 grams. Based on past experience on other equipment with similar clearance (2), the critical particle size, which can cause significant damage, is approximately 6 μm . Although the

Parker system has improved the filtration performance, for the ultimate practical protection, a 5 μm filtration system should be investigated.

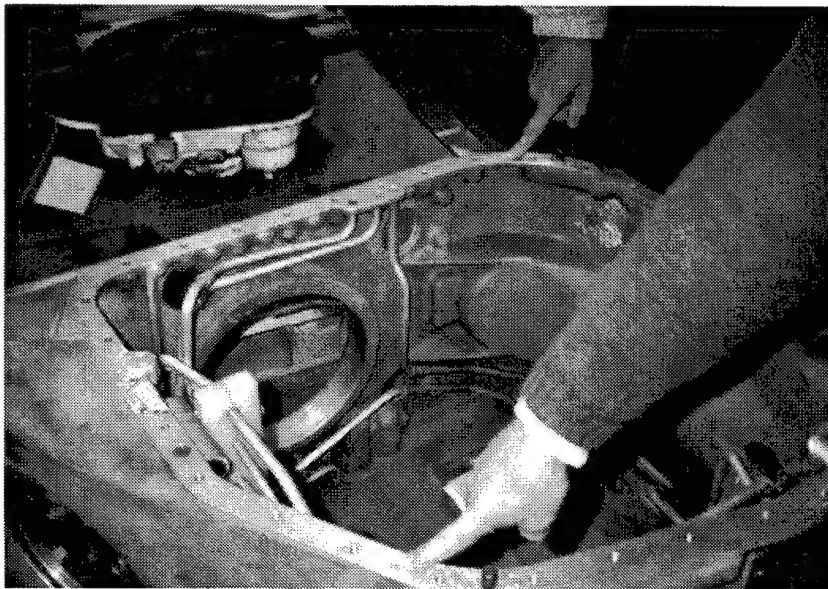
Figure 8. Flange Deformation Due to Jackscrews

Speed change housing problems included housing cracks from jackscrews (Figure 8), fan drive universal joint failures, tubing swages, mismatched nylon tube locating blocks, bearing bore damage from spun bearings, and housing warpage from crack welding procedures.

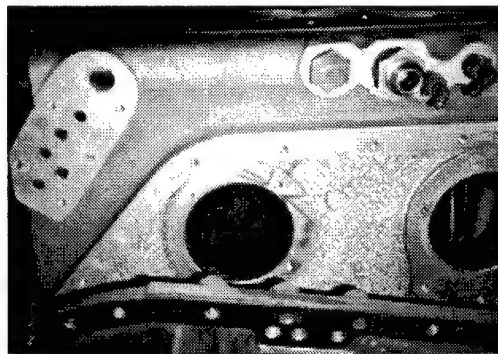
Figure 9. Bearing Bore Damage

Inspection of several speed change housings indicated the bearings for the clutch shafts have been spinning within the bearing bores. The bearing press-fit is obtained by heating the aluminum housings to 300°F and cooling the steel bearing to -38°F. AERA, Inc. analysis suggests when the housing and bearings reach room temperature; the stress in the housing bores exceeds the yield strength of the material, relieving some of the press-fit (Figure 9). When the transmission reaches its operating temperature in the 190-210°F range, the greater thermal expansion of the housing relieves the press-fit and allows the bearings to spin. Housing bearing bores, which reveal extensive damage from spun bearings, are sleeved with a material of higher yield strength.

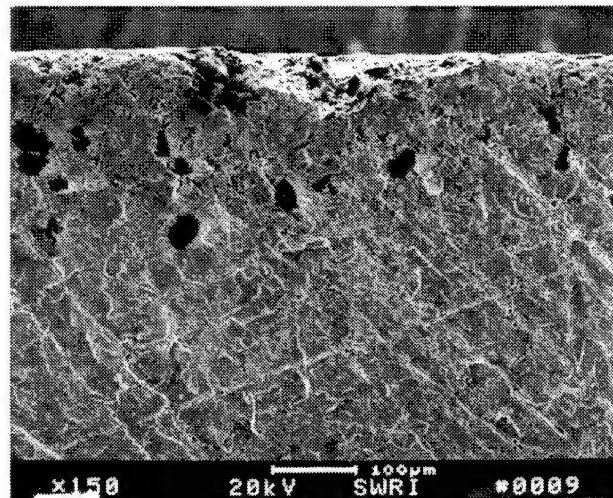
Following the hardness tests, the seal rings were examined under a low power stereomicroscope and in a Scanning Electron Microscope (SEM). The new Twin Disc seal ring exhibited chipping along the machined edges (Figure 10). A large radial crack was also present in the new ring (Figure 11). The broken Twin Disc seal rings (Figure 12), removed from the transmissions at MCAGCC exhibited more extensive chipping than the new seal ring.

Figure 10. New Twin Disc Seal Ring

In summary, although the Twin Disc seal rings performed reasonably well during the transmission test at MCAGCC, subsequent examination of the seal rings indicated that an undesirable wear mechanism (edge chipping) was operating during the test. This wear process produces sizeable wear particles that can cause 3-body abrasive wear of the mating surfaces. The wear that was observed on the cast iron sleeves was likely a result of such wear. Wear of this type can also lead to accelerated wear rates and catastrophic failures. Additionally, the condition of the new Twin Disc seal ring that was examined was unacceptable due to the presence of the large radial crack and a significant amount of edge chipping. Although a single sample may not be representative, the appearance of similar radial flaws on the two used Twin Disc seal rings suggests that these types of flaws may be widespread. In our opinion, the poor manufacturing quality and the presence of an undesirable wear mechanism make the Twin Disc seal rings unacceptable for the proposed application. These seal rings should not be considered as a secondary source.

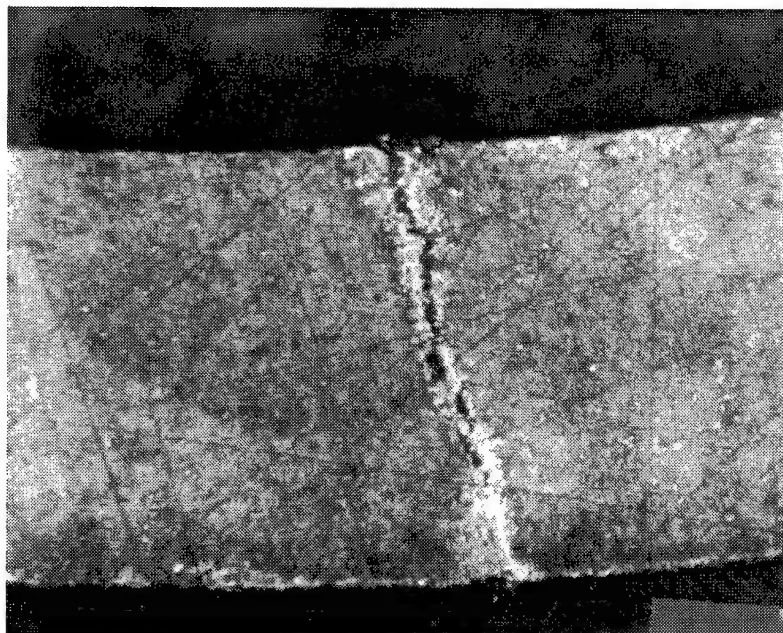
Figure 11. Cracked New Twin Disc Seal Ring

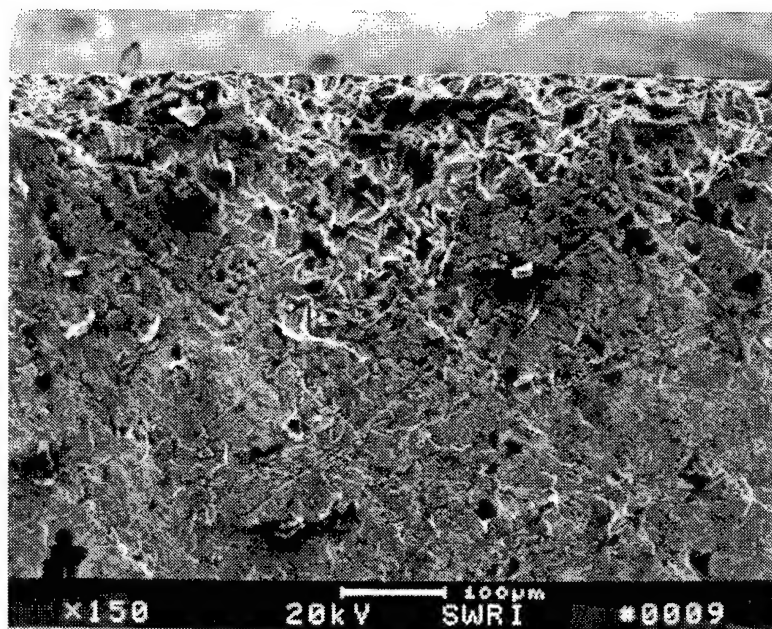
Figure 12. Used Twin Disc Seal Ring

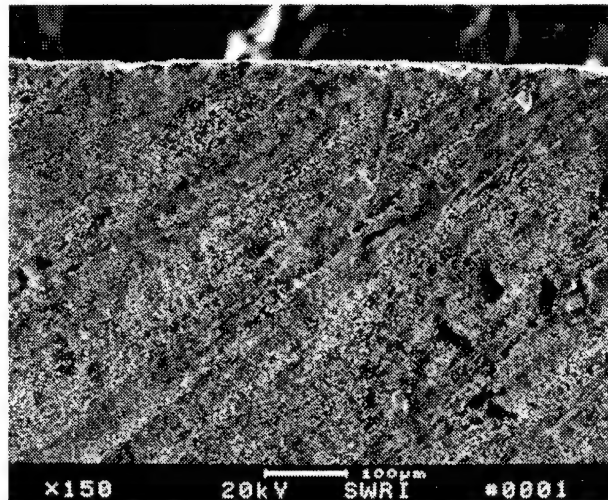
The appearance of the new Aceomatic seal ring was very different from that of the new Twin Disc seal ring. Very smooth edges, as shown in Figure 13, were evident around the entire ring, and no evidence of chipping or cracking was observed. The used Aceomatic seal rings that were delivered to SwRI from Barstow also exhibited smooth edges that were free of chipping and cracking, Figure 14.

Figure 13. New Aceomatic Seal Ring

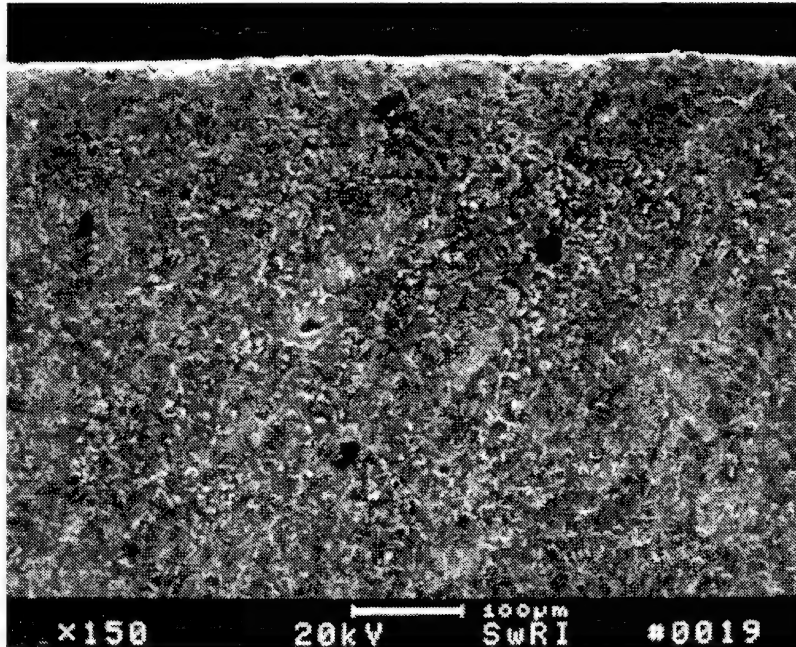
Figure 14. Used Aceomatic Seal Ring

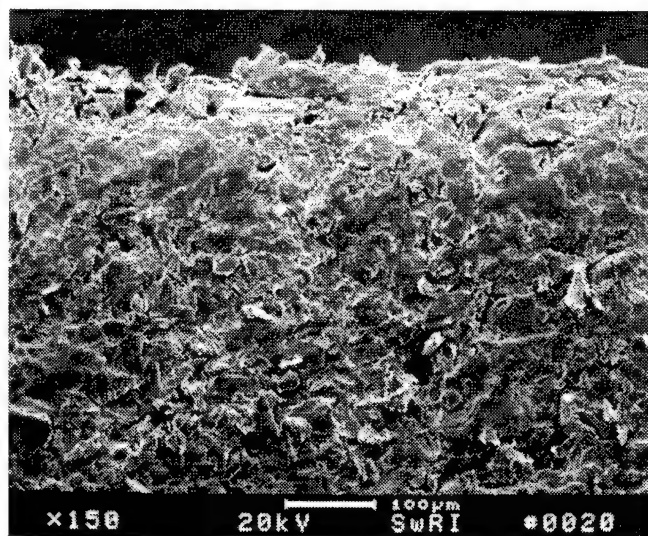
Figure 15. New Teflon Seal Ring

New and used, bronze impregnated, Teflon seal rings were also examined. As expected, their appearance was very different from either of the cast iron seal rings (Figures 15 and 16). However, due to the very different nature of the material of the rings, it is impossible to draw any conclusions about Teflon relative to cast iron seal rings from these micrographs.

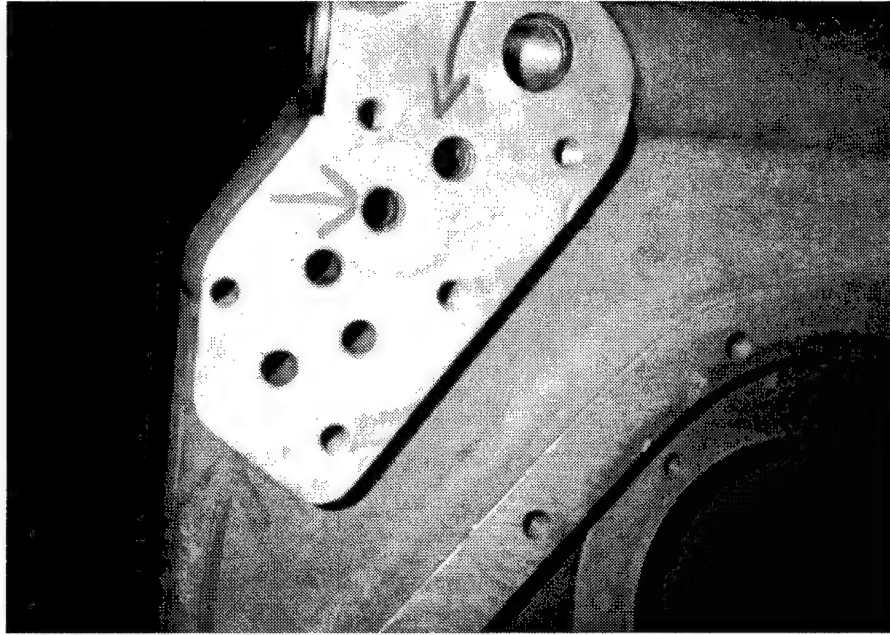
Figure 17. Tube Swage Problem Areas

The problem is once the tubes are swaged into their respective holes (Figure 17); vibration of the material loosens the fit. In addition, if the tube swaging process is not performed correctly, the tubing wall thickness becomes very thin, cracking as a result of fatigue. Both of these problems result in the loss of oil pressure.

The proposed method for the tube swaging is to set a limit on the hole diameters, then swage the tube until the ID of the tube is within a prescribed limit. The procedure will result in a 5% to 15% swage of the tube. The advantages of this method are that the number of measurements is reduced and no calculations are required. It will also be easy to determine in a post inspection if the tubes were properly swaged simply by measuring the ID of the installed tubes. The ability to check the degree of swage of an installed tube will be very helpful toward eliminating the improperly installed swage tubes. Although this procedure should aid in reducing the number of tubing swage problems, it is felt that this problem needs additional investigation to produce a better solution.
